New solar PV panel renovation/repair technologies for demanding climate using polysiloxane

Prof. Dr. V. Poulek
Inova Solar sro
www.solar-trackers.com
info@solar-solar.com

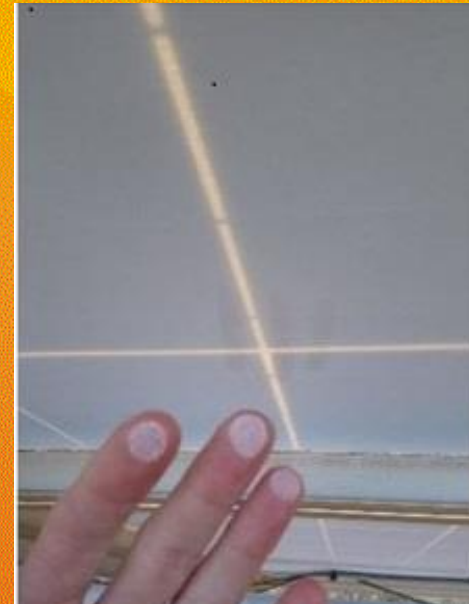
Risol (ground impedance) typically about 500Mohm

Visual appearance – invisible. Touching the back sheet TPT by hand, white powder adhere to fingers - “chalking”. See photo below

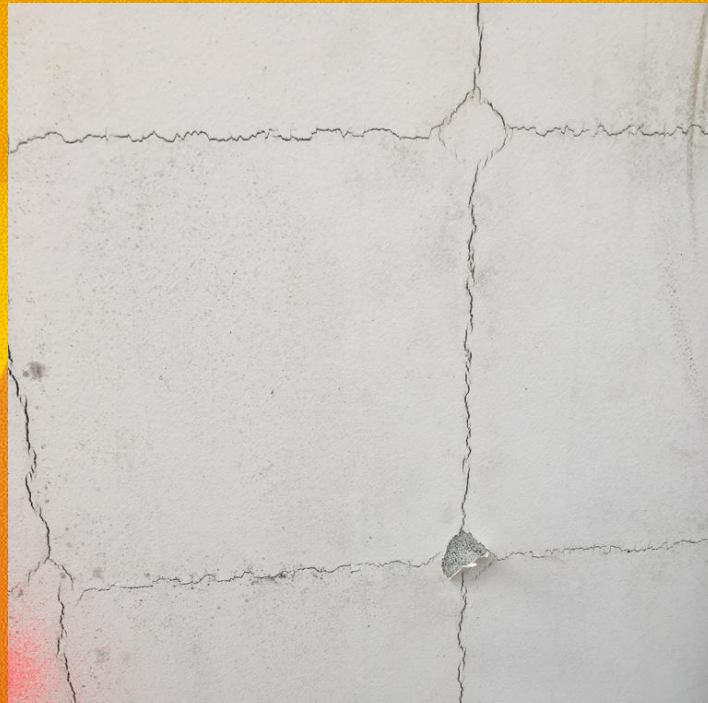
Risol (ground impedance) typically about 100Mohm

Visual appearance – large cracks at the back sheet TPT See photo below

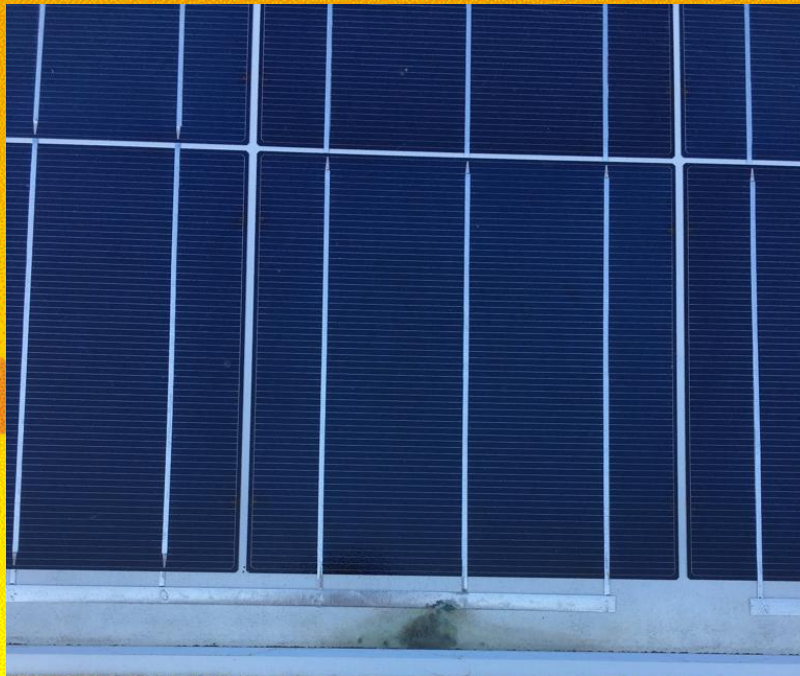
Risol (ground impedance) typically below 25Mohm

Visual appearance – discharge channel between busbar and the grounded frame. See photo below (bottom-centre)

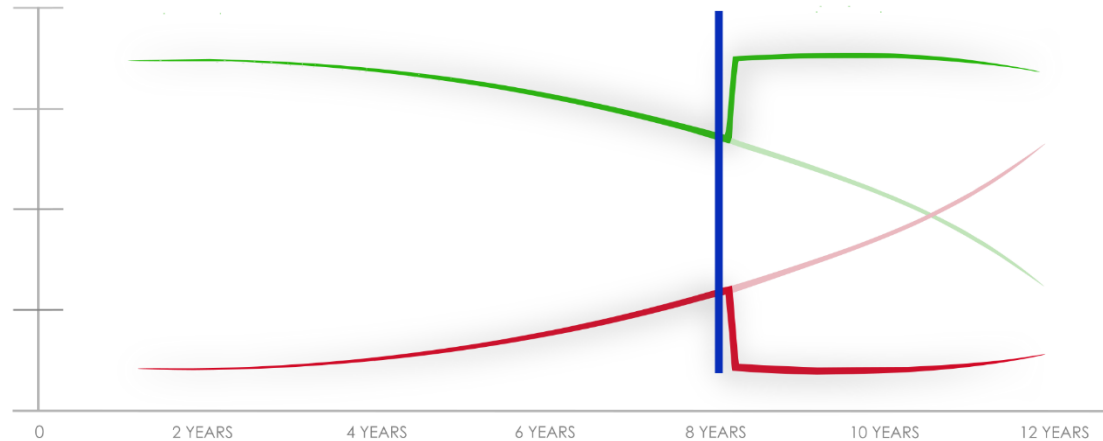
PV PLANT RENOVATION MODEL

PV PLANT OWNERS PROFIT

PV PLANT SERVICE EXPENSES

PV PANEL RENOVATION MOMENT

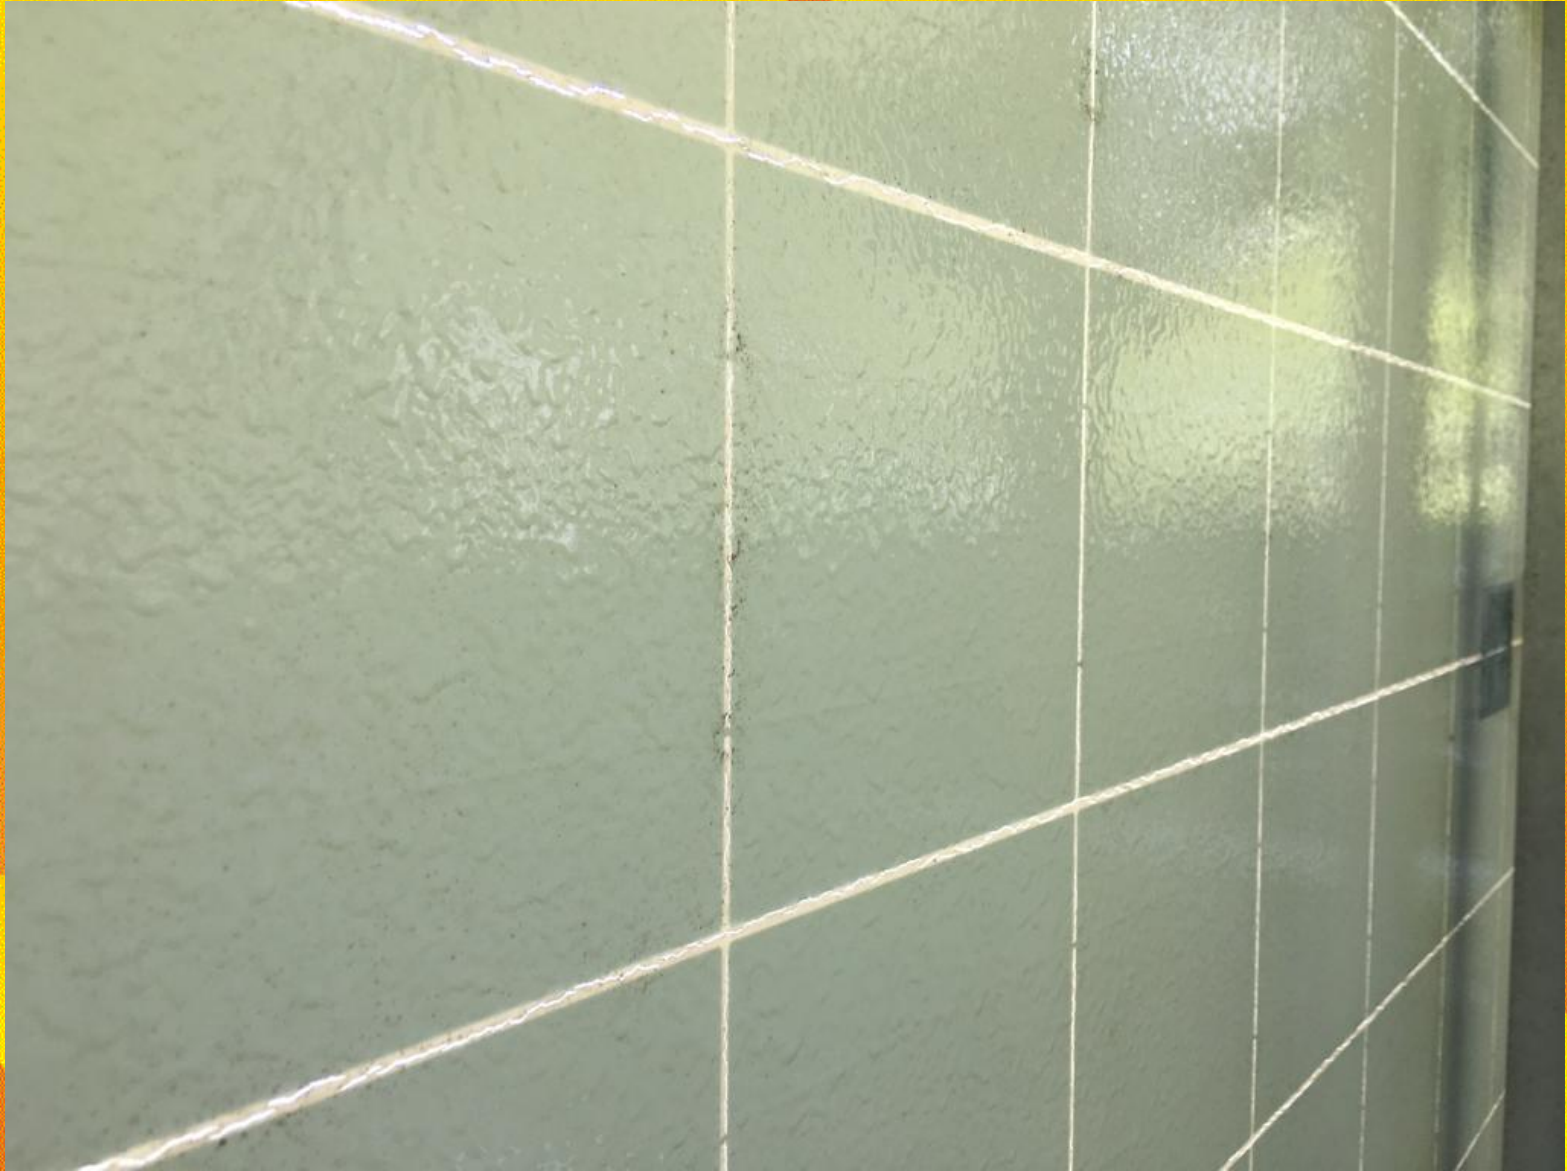
PV panel back side after siloxane film application

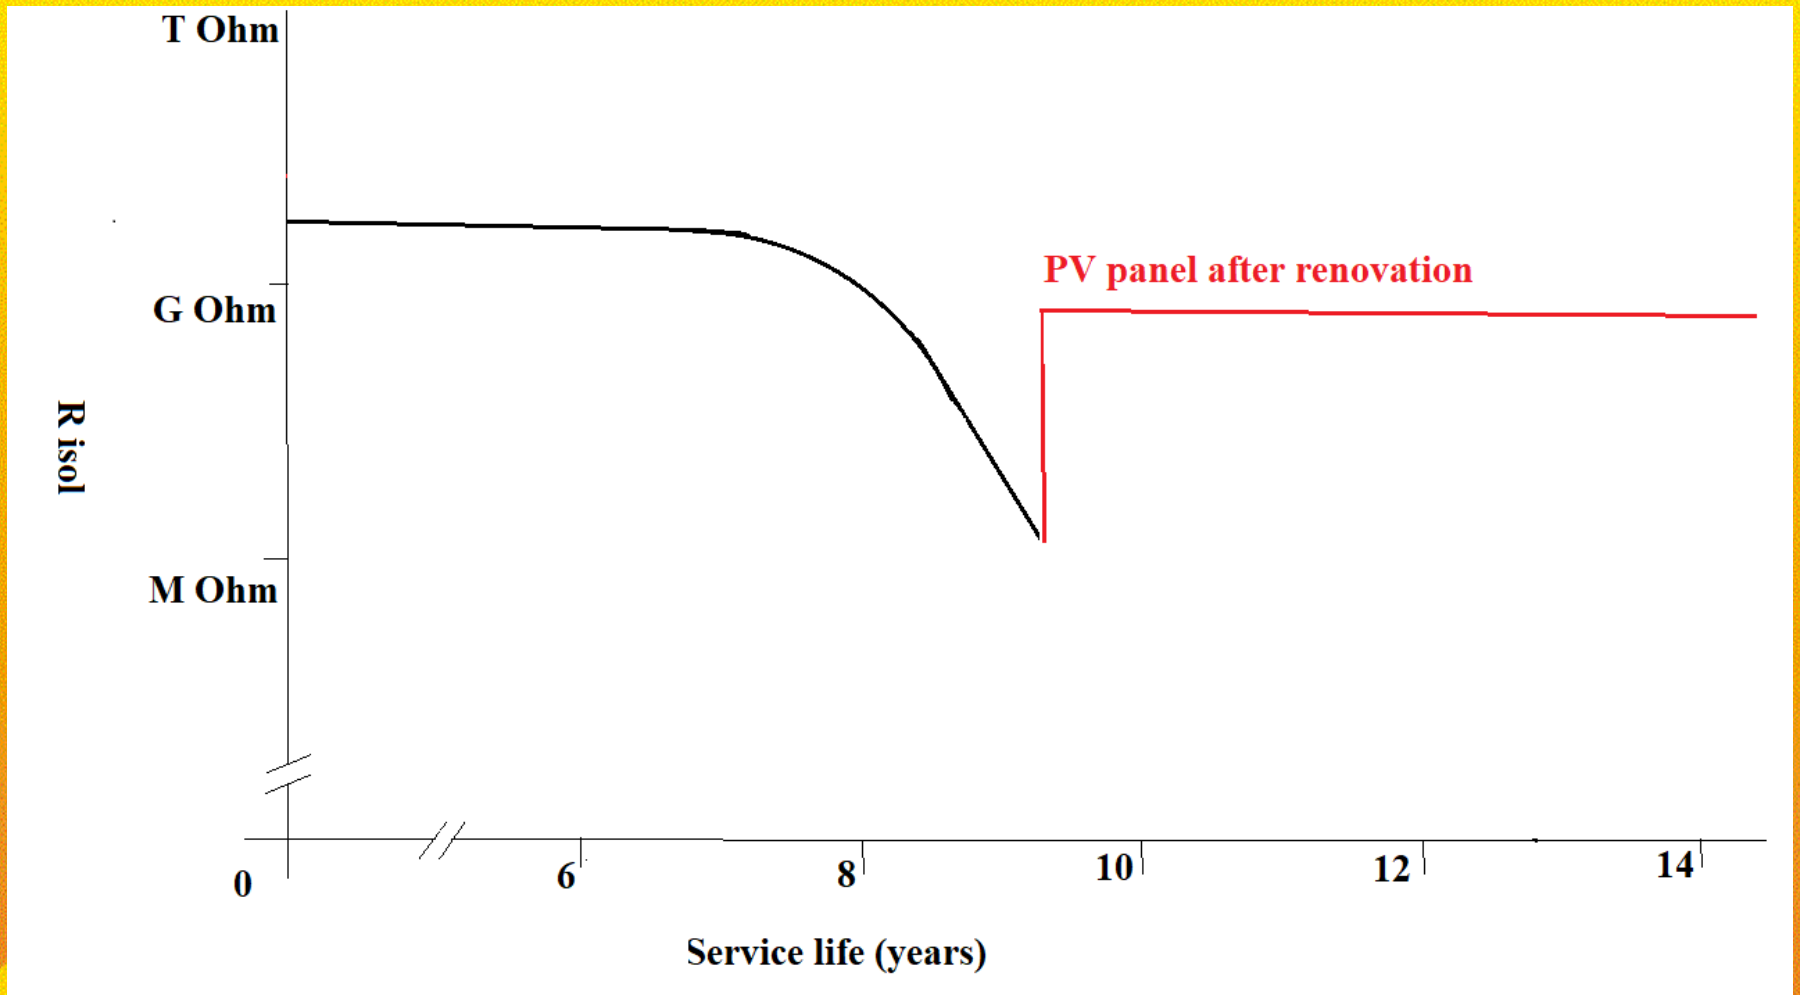
Ground impedance (Risol) before and after PV panel renovation

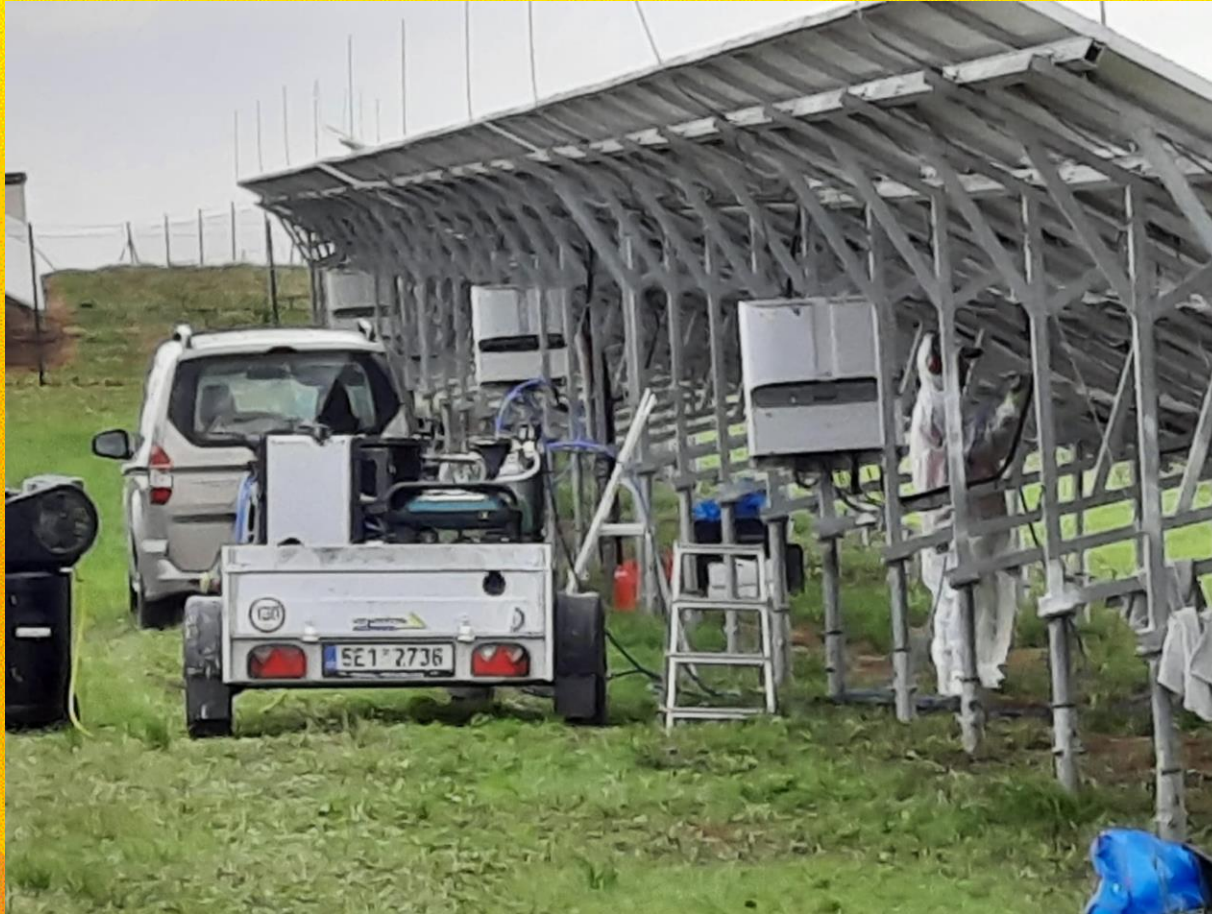
PV panel renovation equipment at 3MW PV power plant

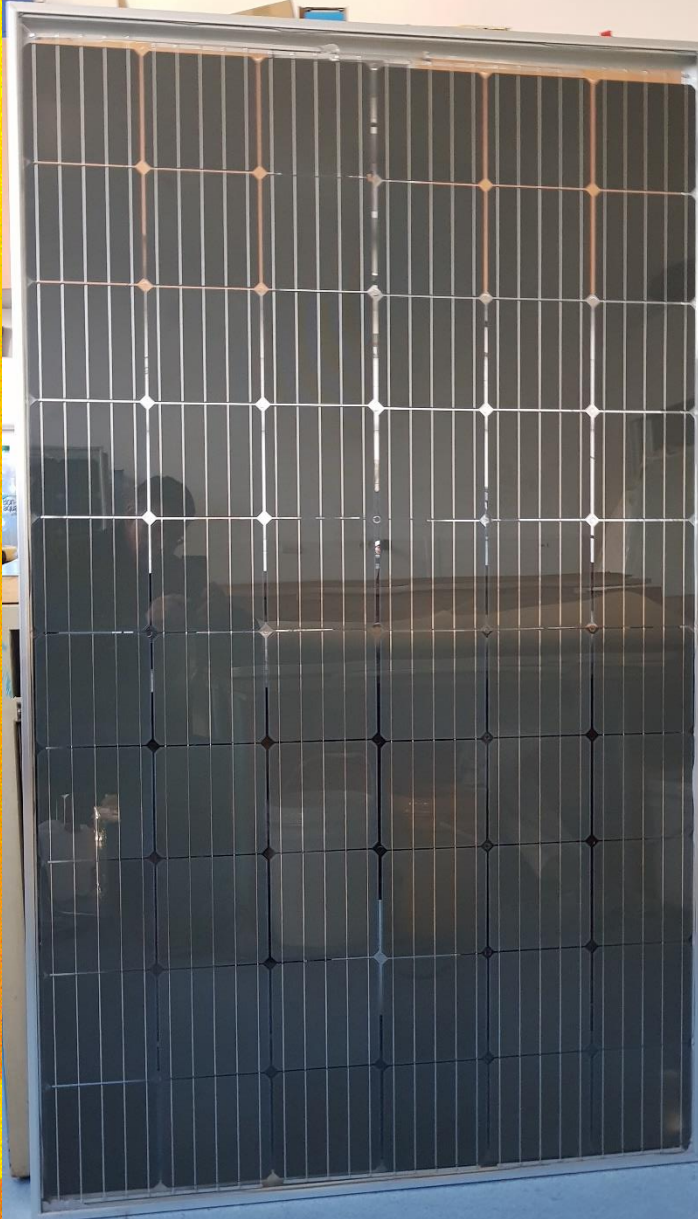
PV panel laminated by polysiloxane

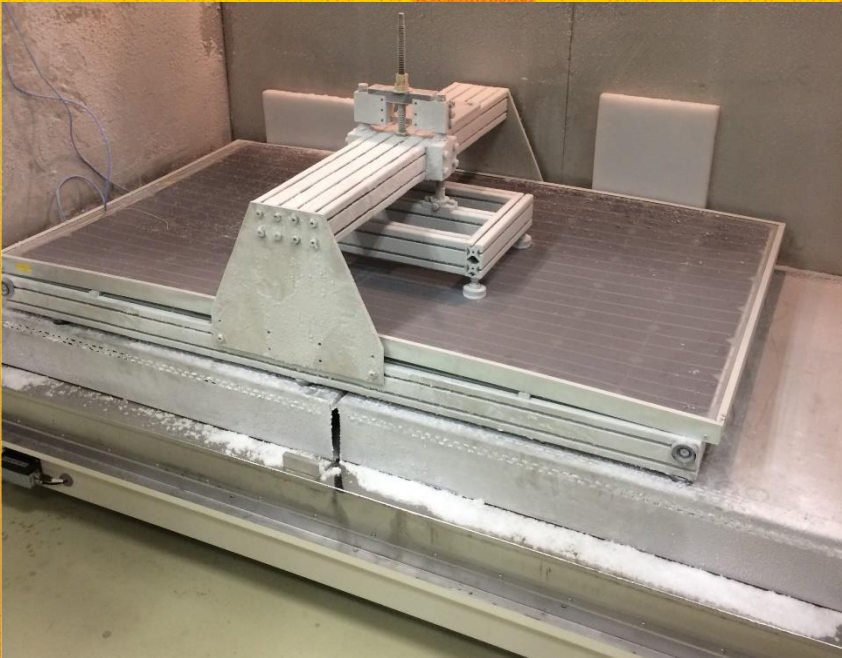
PV panel load test at -55°C

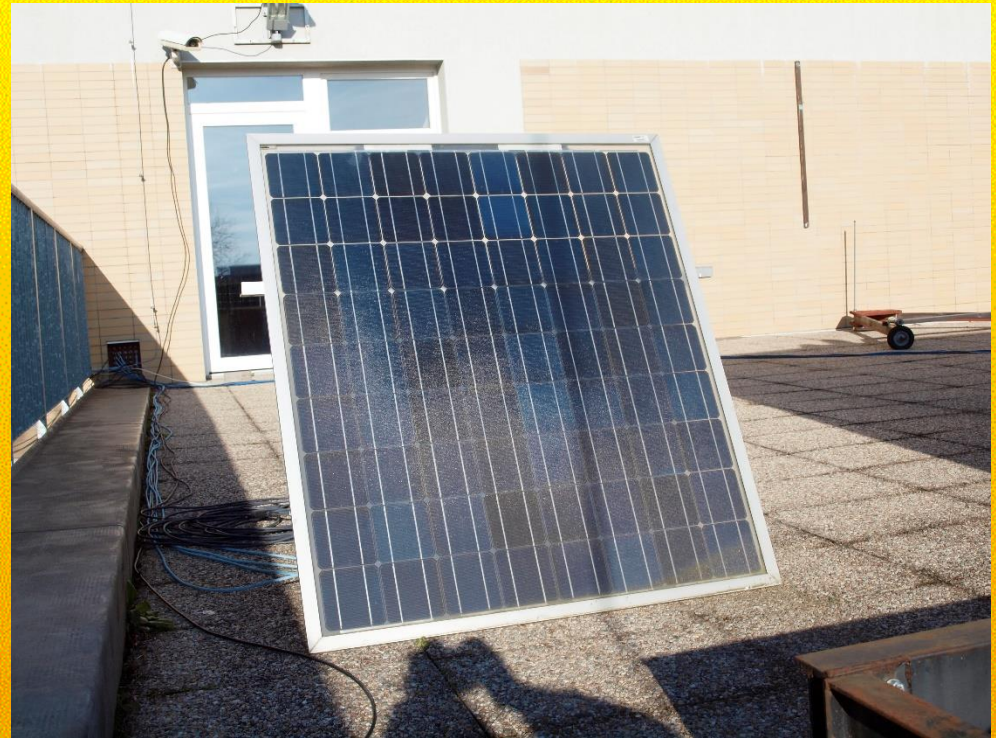
Evaluation of TRAXLE panels after 12 years outdoor exposure at Czech University of life sciences in Prague show degradation 0.2% per year.

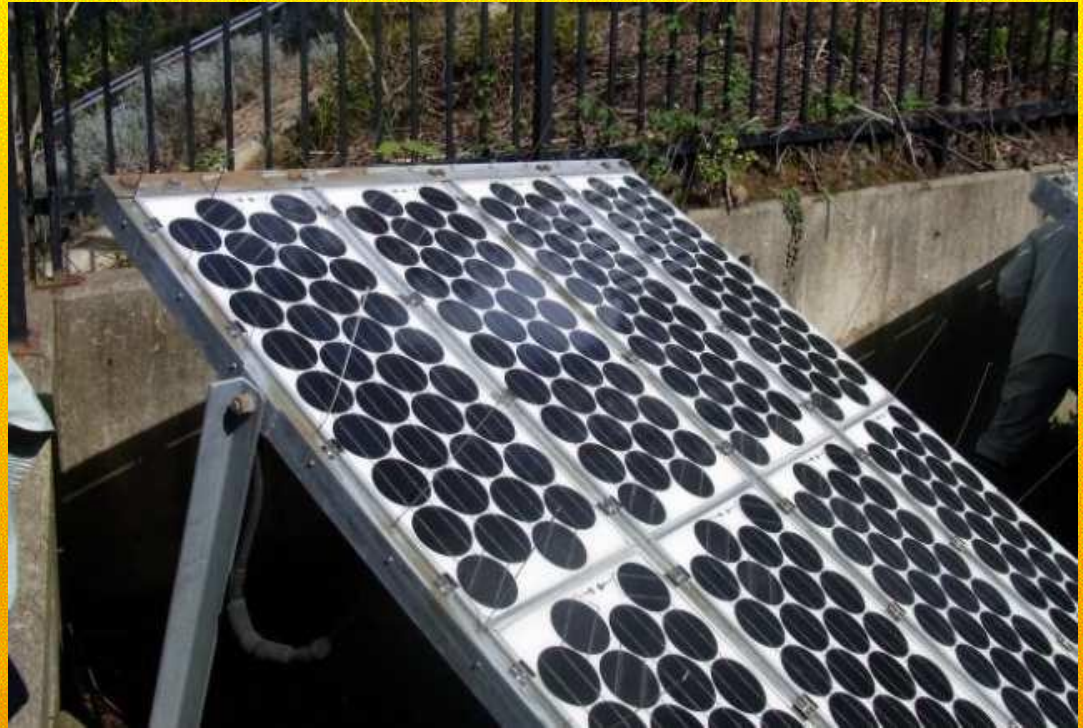
Sharp and BP solar panels laminated by silicon (same materials but very expensive and very difficult lamination technology) after outdoor testing for 29 and 26 years show 0.21-0.22 degradation according to respected reports

29 years old silicone laminated PV panels (Japan)
